THE RESISTANCE OF BERYLLIUMIZED SURFACES TO HIGH TEMPERATURE SLAG CORROSION

Research and Development Report 910088 NS-013-120

22 October 1958

U. S. NAVAL ENGINEERING EXPERIMENT STATION

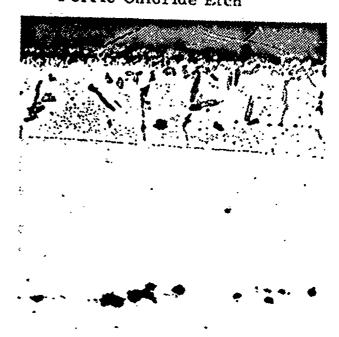
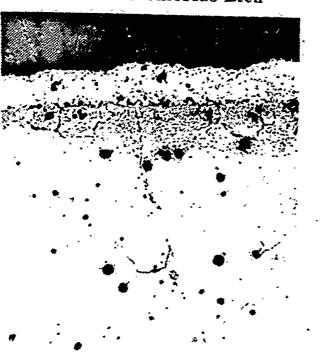
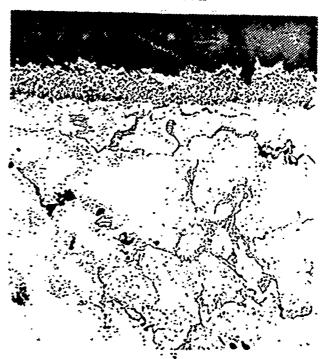
Figure 1 Photomicrographs of Beryllium Diffused Metal Surfaces (X250)

Photomicrographs of the processed surfaces are shown in Figure 1. Total depth of the coating or diffused layer appeared to be 0.0044" for the stainless steel, 0.0016" for the Inconel, and 0.0016"

for the Stellite. Diffusion to greater depth probably occurred, but the concentration was not sufficient for phase formation, and the maximum depth could not be indicated by the etching technique. Extensive diffusion occurred in the berylliumized layer on the Type 310 stainless steel. Complex metallic phases were distributed from the surface to the base metal interface. The variable etching rates, which occurred in selected reagents, indicated the surface phases to be high in beryllium. Some needles of a high beryllium phase, however, extended to the substrate interface. Signs of eutectic phases were also found in the berylliumized layer. Phase diagrams, reference (h), show that nickel and iron series of alloys with beryllium contain complex intermetallic compounds with associated eutectic compositions. The locations of nonmetallic inclusions in the diffusion layers indicated that the diffusion or growth of the layers was predominately inward into the base material. Both the becomel and Stellite also showed characteristics of extensive diffusion, although somewhat different than the Type 310 stainless steel. Diffusion or beryllium in the base material beyond the phase concentration line as quite obvious in the Inconel. Grain boundary diffusion was apparent this low concentration area. Little or no diffusion in the substrate was indicated in the Type 310 steel or the Stellite.

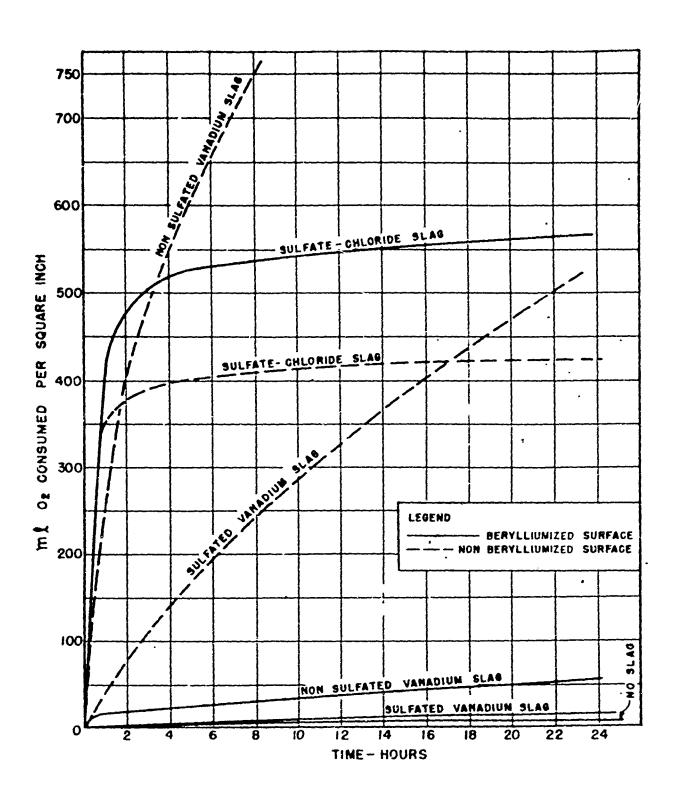
Figure 2 Oxidation of Berylliumized Type 310 Stainless Steel

The berylliumized Type 310 stainless steel surfaces exhibited considerable resistance to vanadium slags over a 23-hour history. No metallic surfaces studied to date have shown greater resistance. However, the berylliumized stainless steel showed poor resistance to the sulfate-chloride slag. In fact, the processed surface was less resistant than the base material.

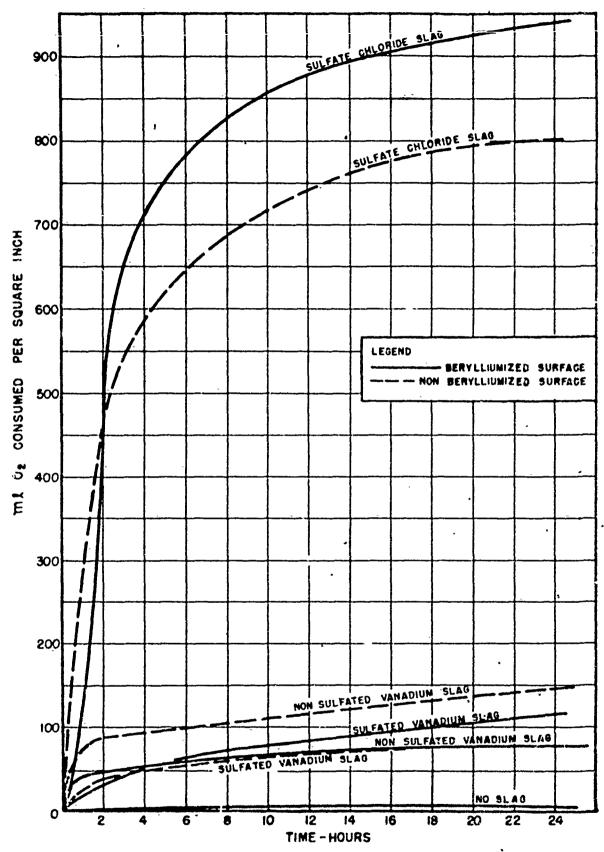
Figure 3
Oxidation of Berylliumized Inconel

The berylliumized Inconel was highly resistant to vanadium slags. However, no improvement was considered to have been induced by the process, as Inconel itself is highly resistant to vanadium slags. As with the stainless steel, the berylliumized Inconel showed less resistance to sulfate-chloride slag than an unprocessed Inconel surface.

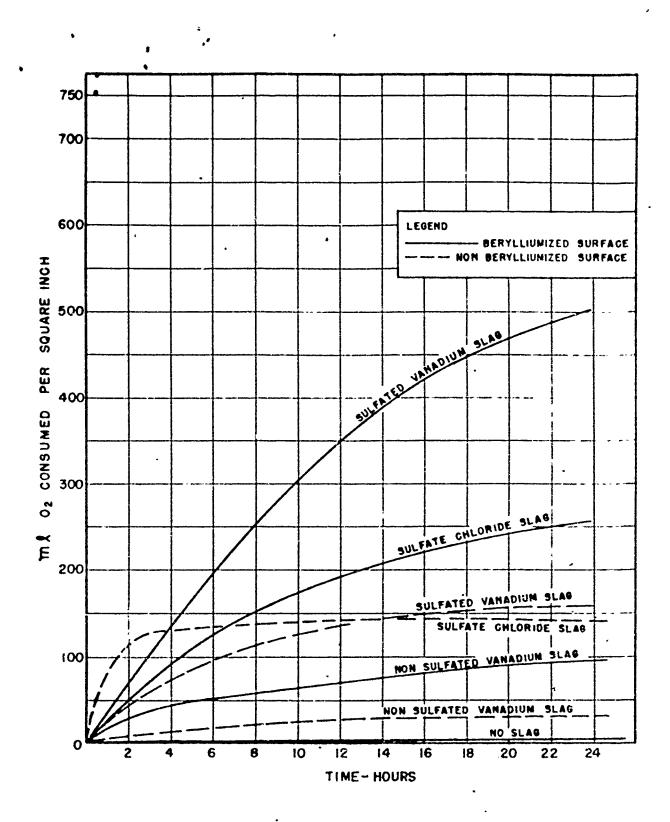
Figure 4
Oxidation of Berylliumized Haynes Stellite 31

The berylliumized Haynes Stellite 31 surfaces were less resistant to all slags than the unprocessed surfaces. The berylliumized surfaces suffered exceptionally severe damage from the sulfated-vanadium slag. The resistance to this slag of the processed surface was estimated to be 30% of the uncoated Haynes Stellite 31 material.
